# Windsor Theatre Auditorium Ceiling Project

Updated 10/19/26

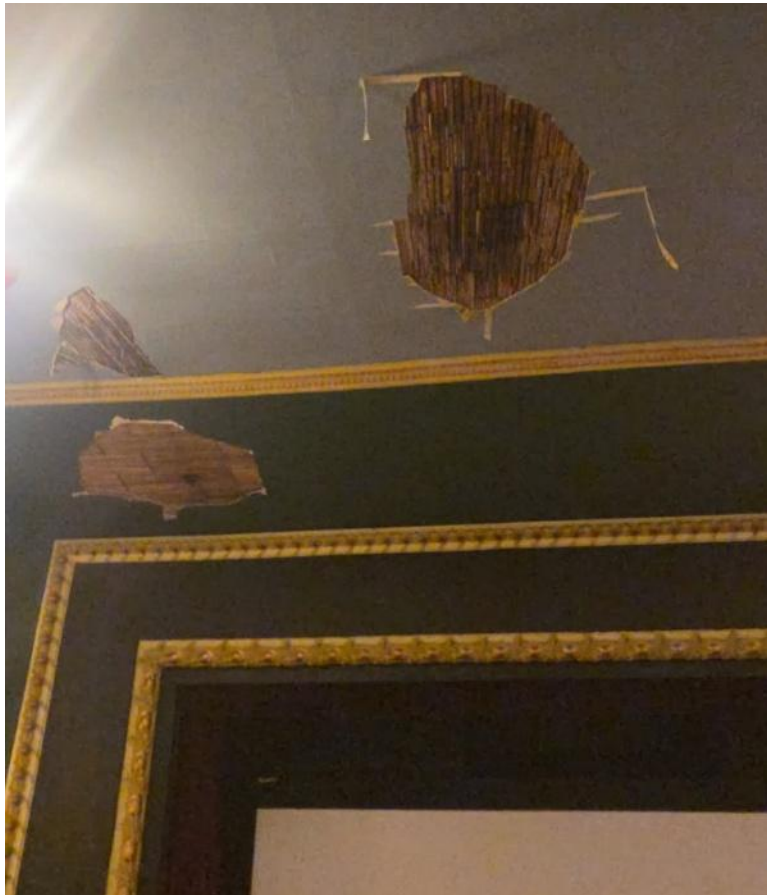
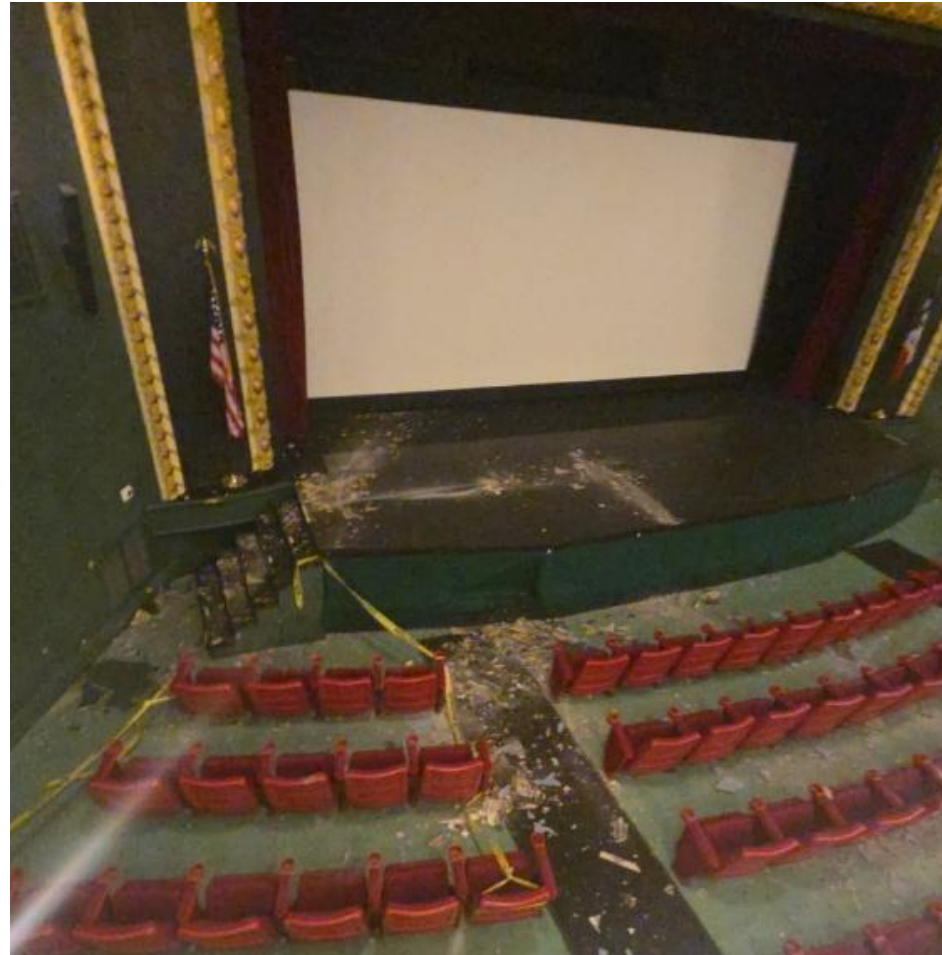
Three sections of the original plaster ceiling inside the Windsor Theatre auditorium fell on July 18 and sometime between the evening of July 26 and the morning of July 29. The falling plaster exposed the wood lath beneath the ceiling and prompted seating restrictions until repairs could be completed. No one was injured, although several seats were damaged.

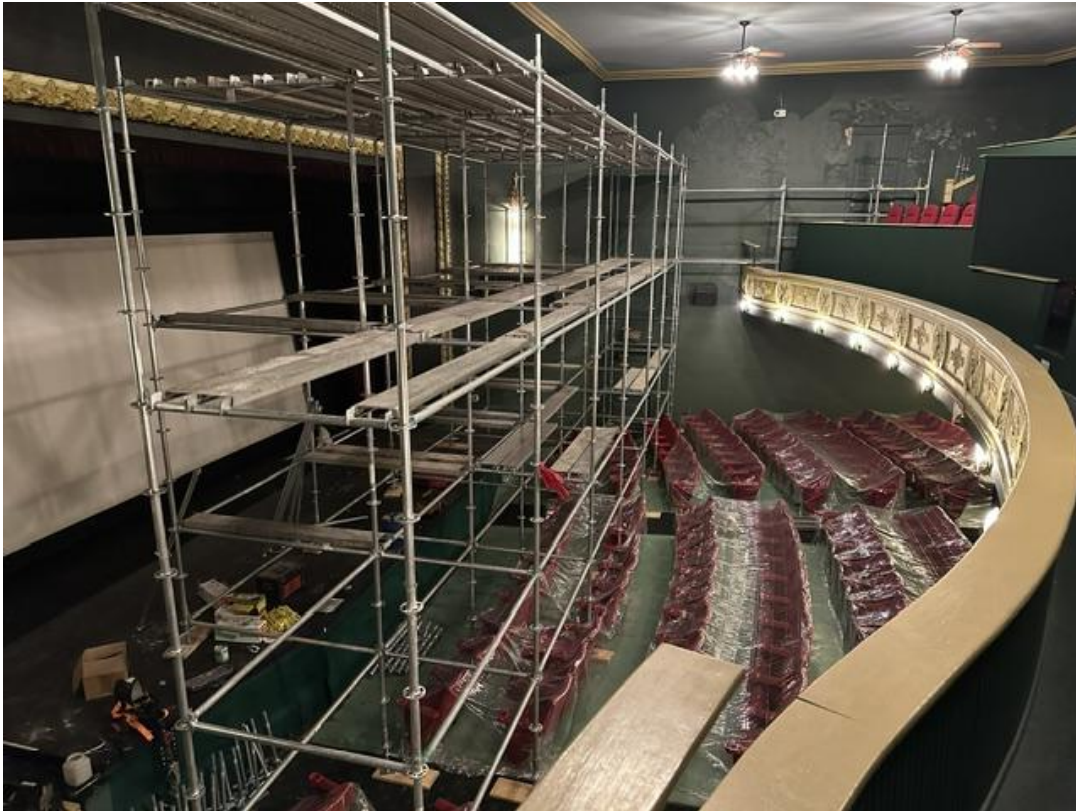
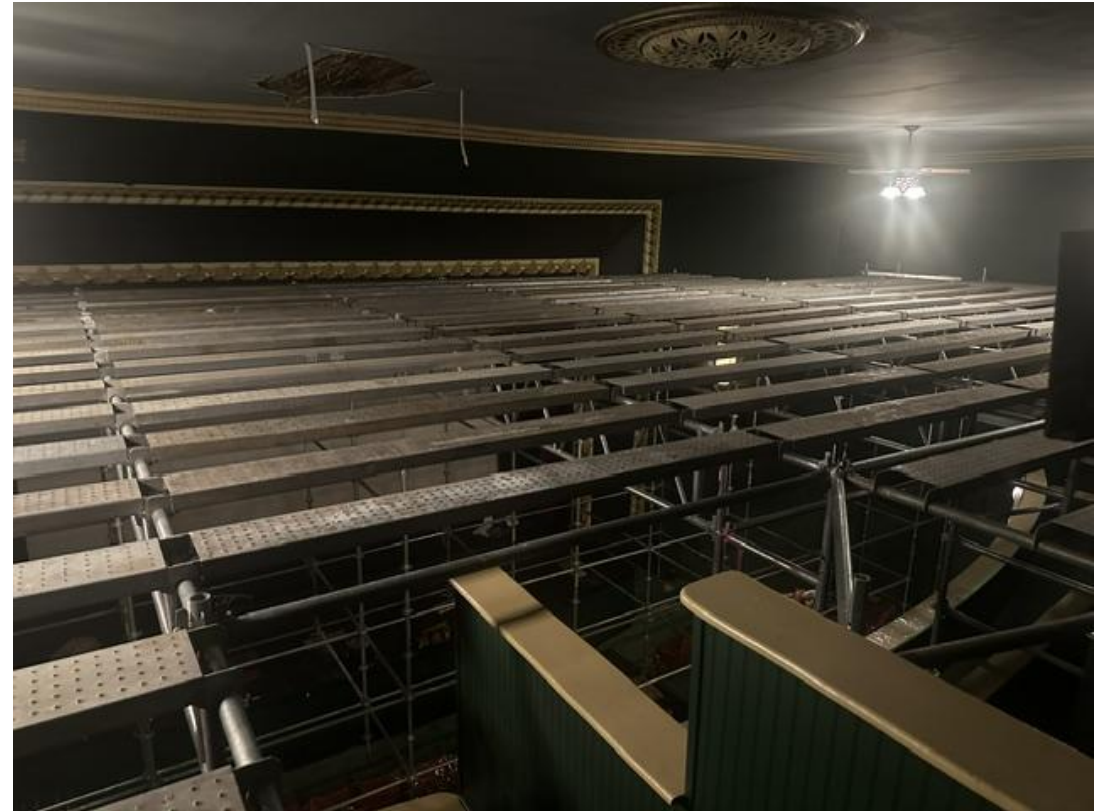
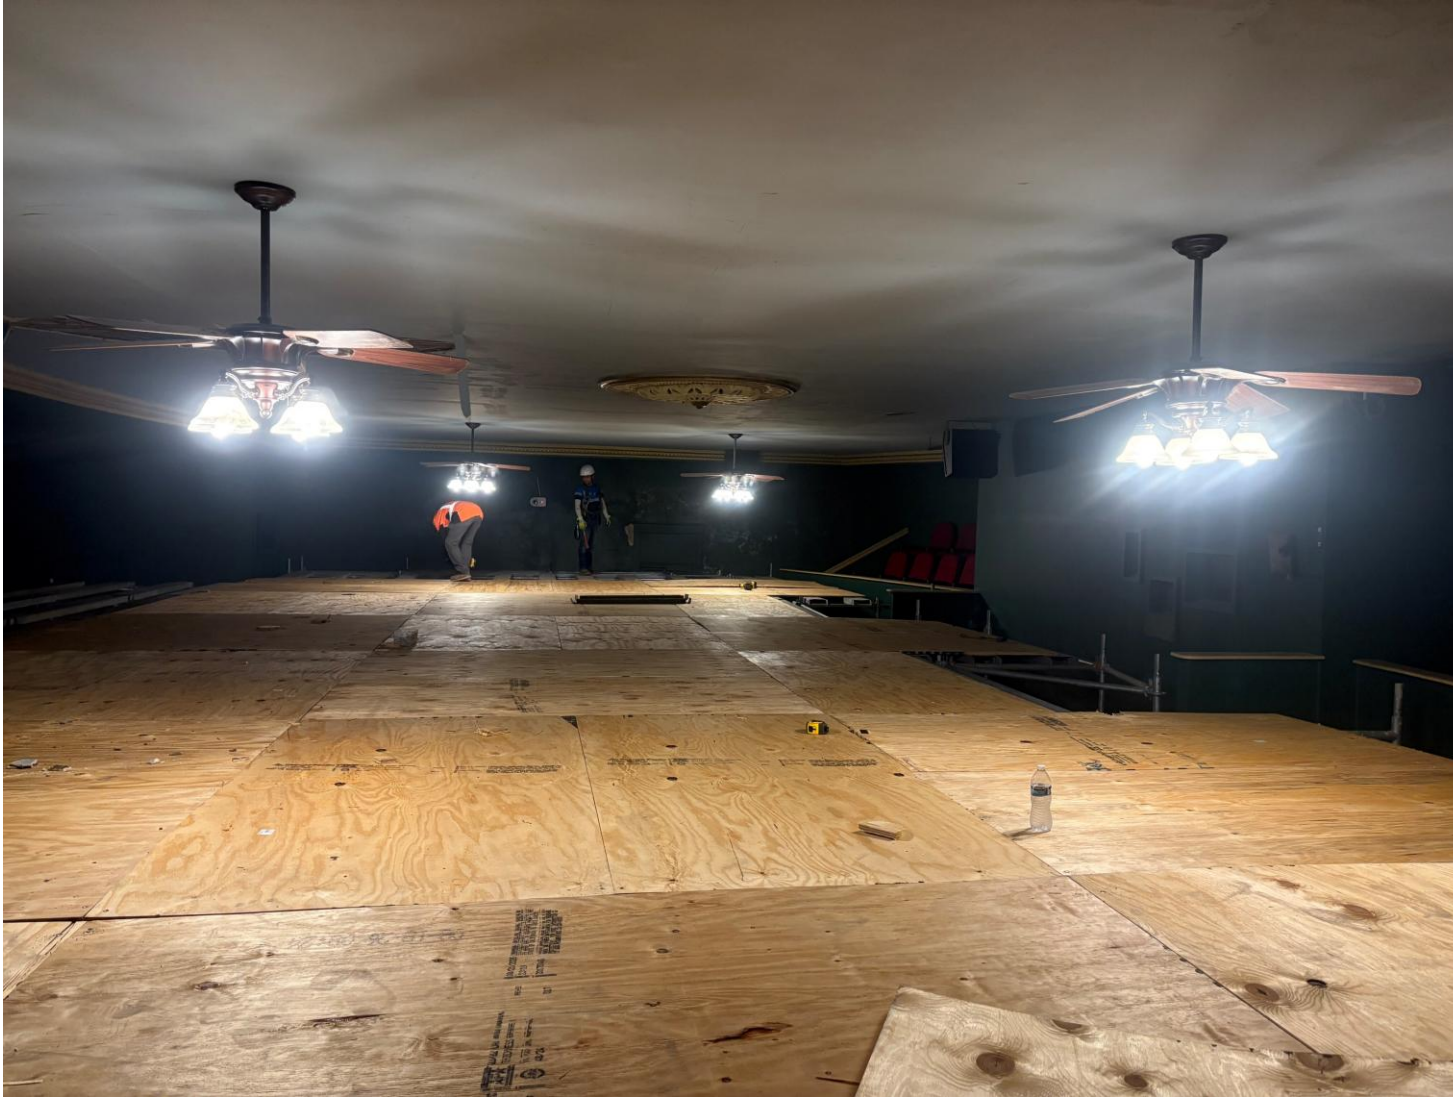
Installation of the scaffolding began Tuesday, September 22 to provide access to the ceiling in preparation for removal of all existing plaster. Seats are covered in plastic to protect them during the ceiling reconstruction. Plastic has also been hung to provide a barrier to minimize dust from entering the lobby, hallway, and area under the balcony.

By the end of the day Friday, September 25, scaffolding topped with plywood flooring had been installed. The next step is to remove the ceiling fan lights.

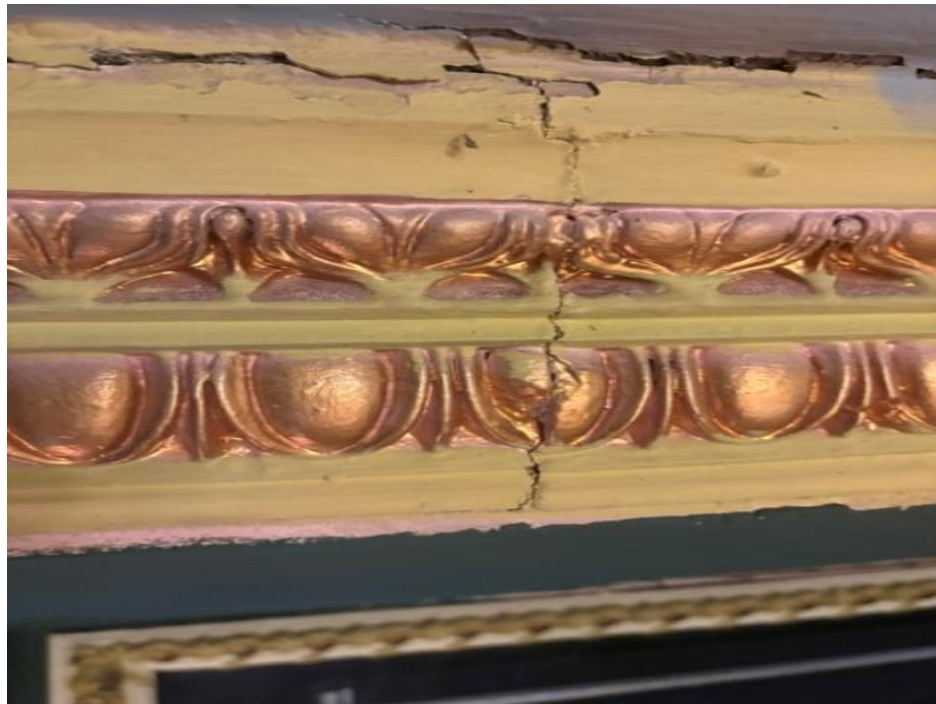
Cracked crown molding at the junction of the auditorium ceiling and wall is shown, along with a close-up of a vertical crack. Some additional work will need to be done to secure the molding to the wall.

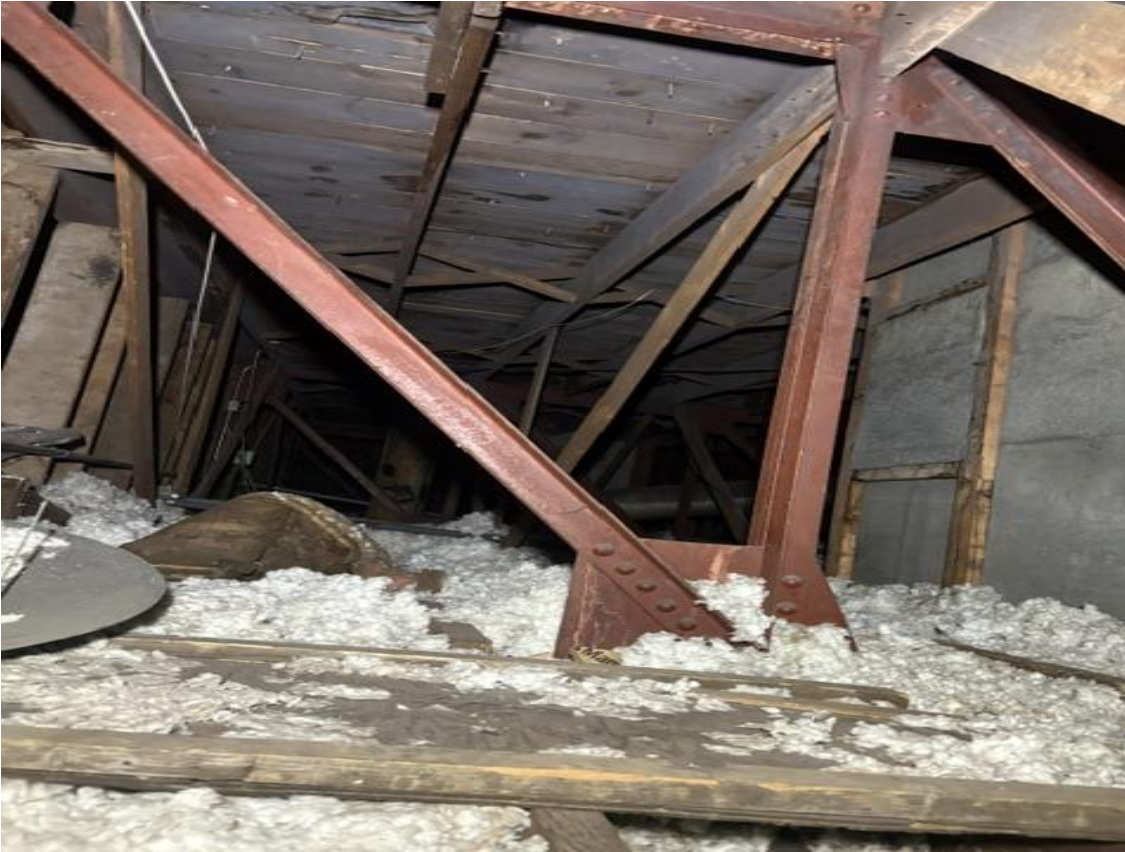
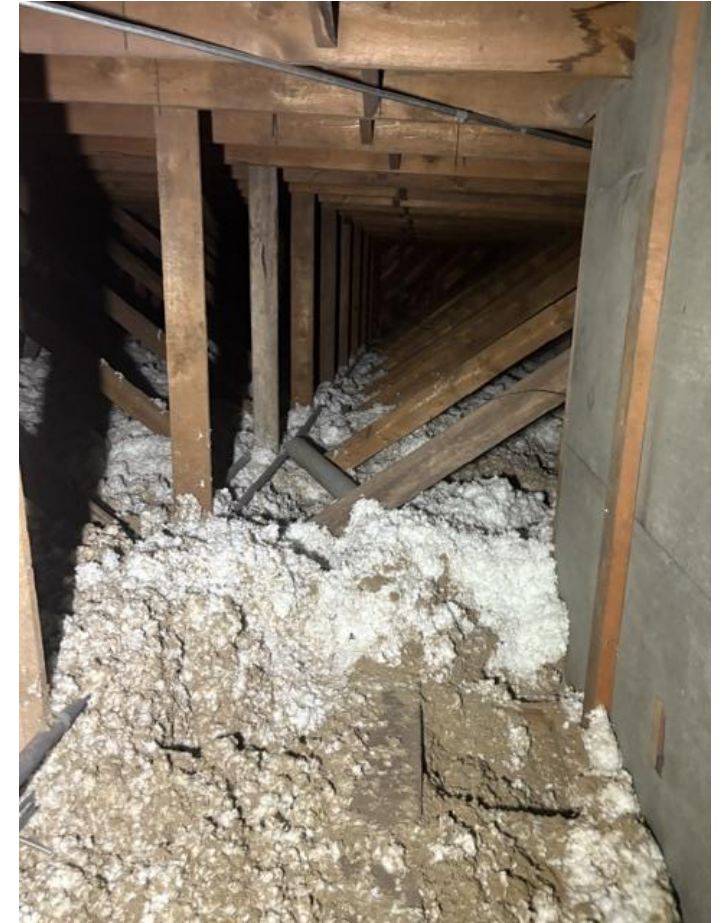
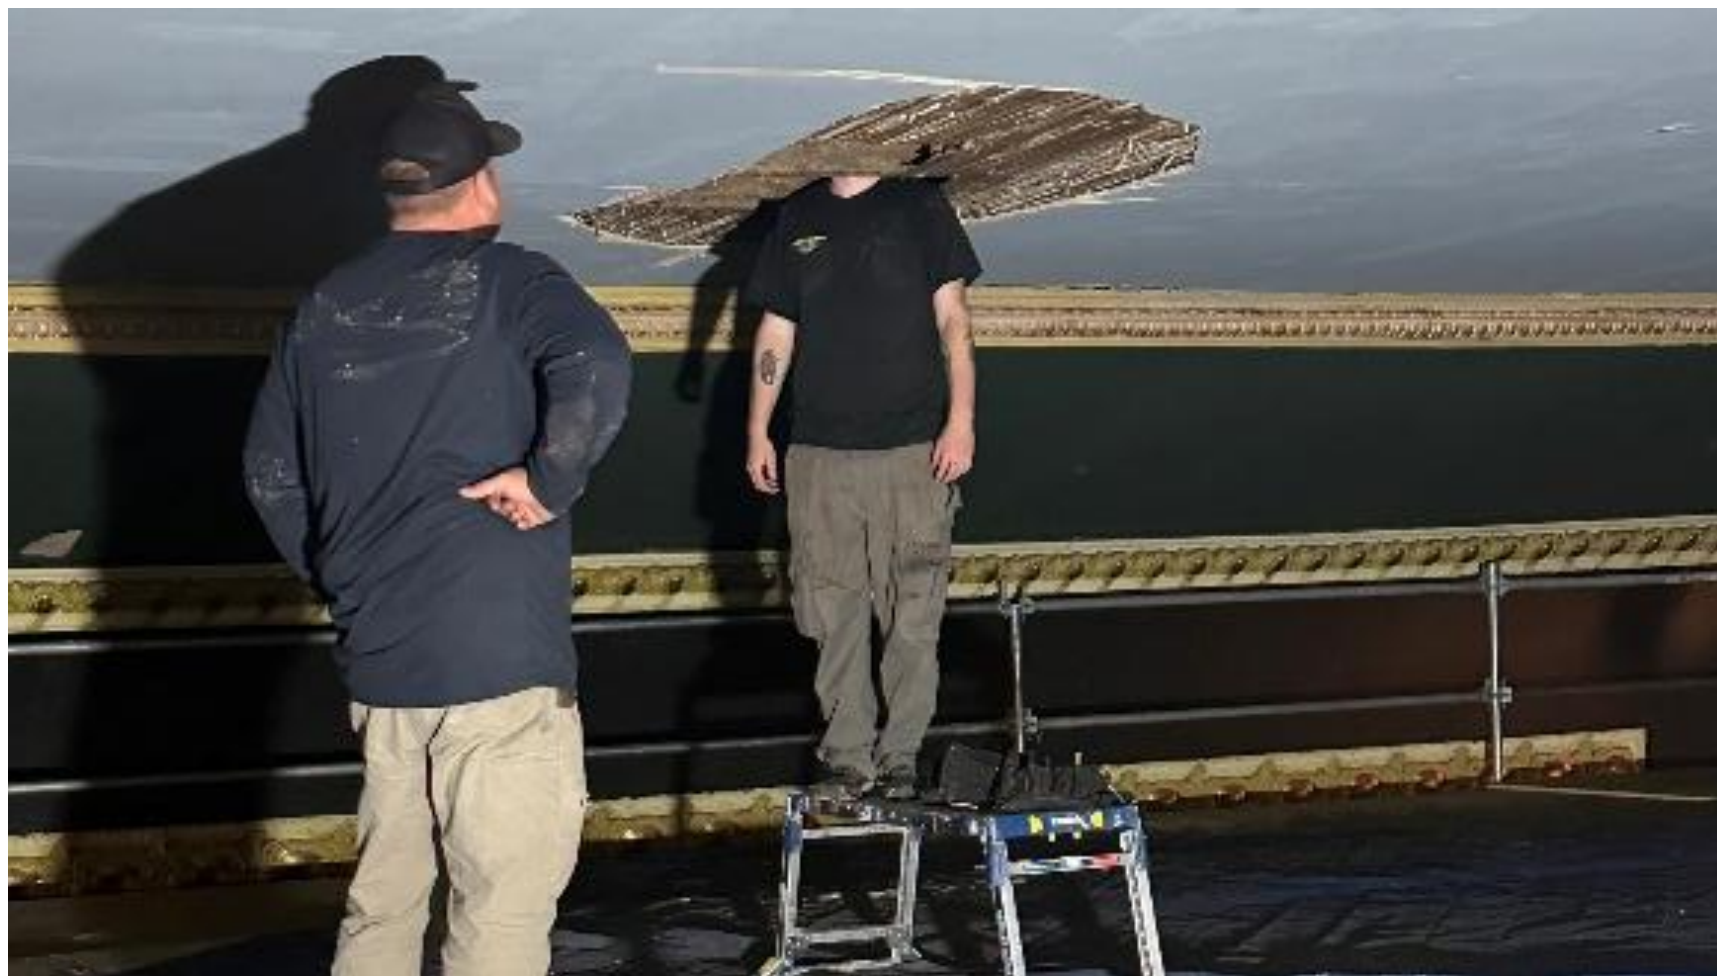
The space above the auditorium ceiling and below the roof contains the building's support structure. Large beams and rafters carry the heavy roof loads and transfer the weight to the ceiling joists. The original wood lath and plaster ceiling is attached to these joists. The white snowlike powder is insulation.

A construction worker looks above the ceiling after a small section of the existing plaster ceiling and lath was removed. The top of the scaffolding has been covered with sheets of plywood, creating a work platform for workers to begin demolition of the entire ceiling.

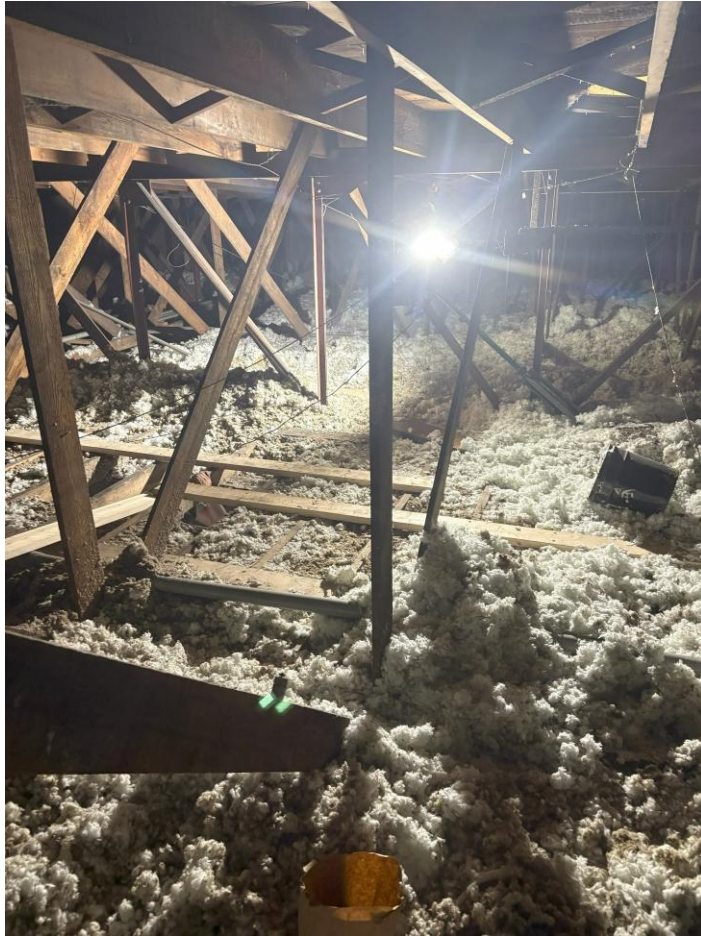
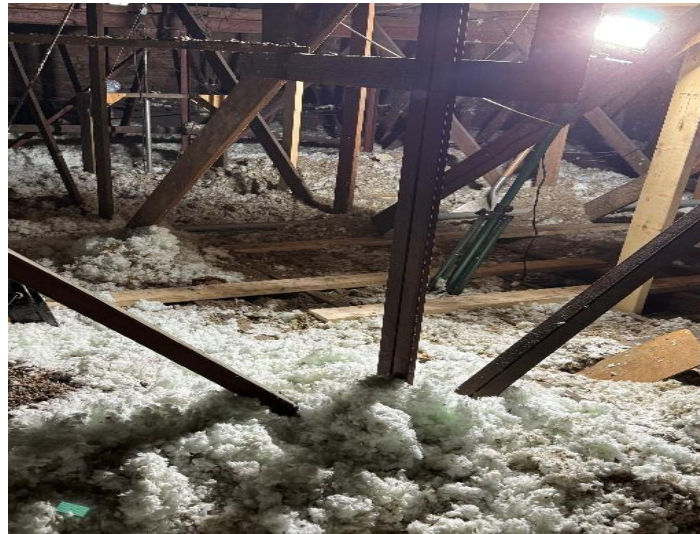
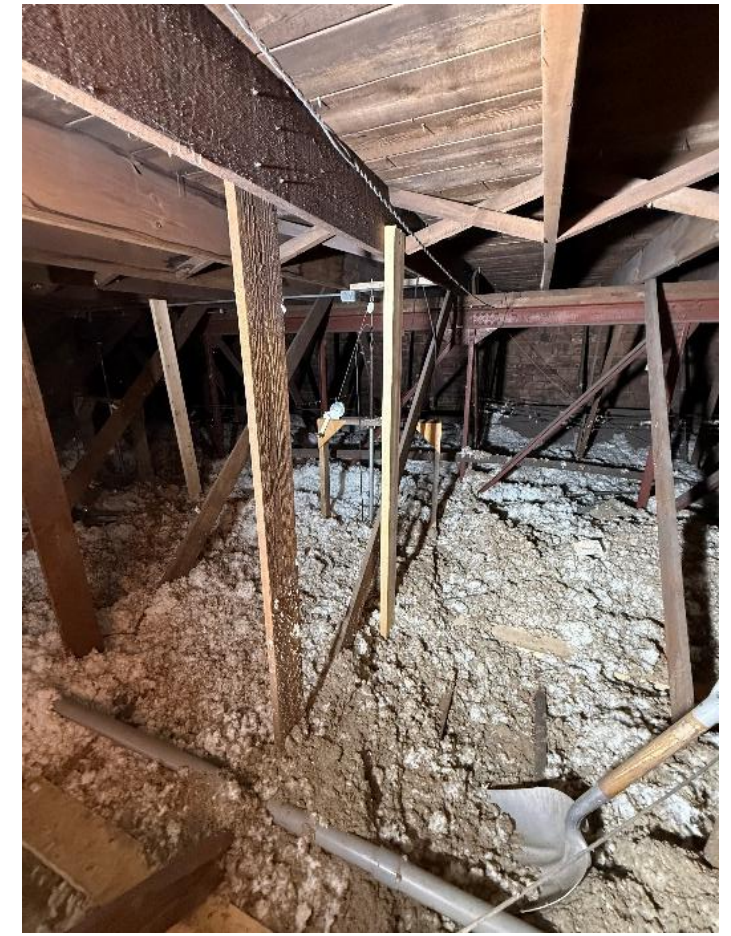
Pro Wall noticed after taking down the plaster that between each of the roof trusses there was significant sagging. After investigation, they noticed that the joists that were previously installed between the trusses were just free floating and not attached to anything. Pro Wall installed 2-by-6-by-10-foot boards laying them flat along the trusses to act as a stiff back to strengthen the joists between the roof trusses. They also installed 2-by-6 studs vertically in spots to help strengthen the trusses.

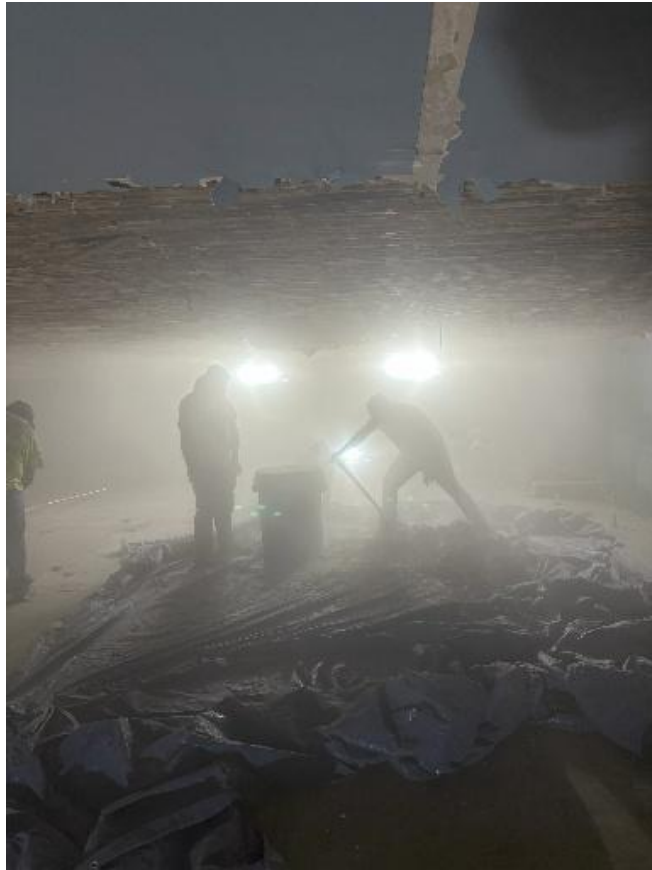
Plaster removal is a dirty, dusty job.

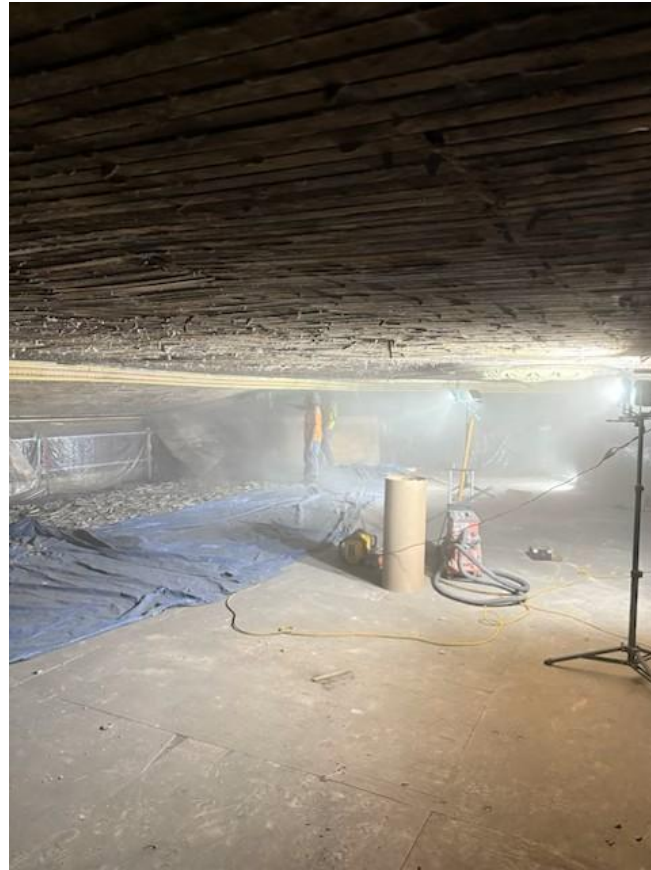
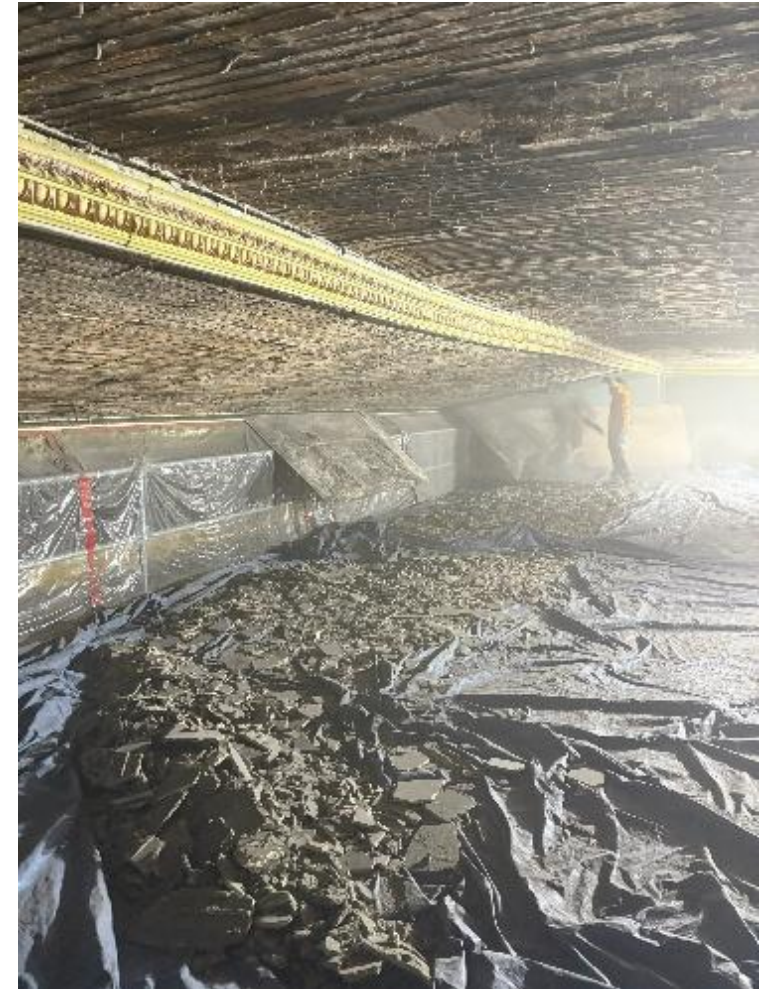
Plaster is down, to be soon out of the building.

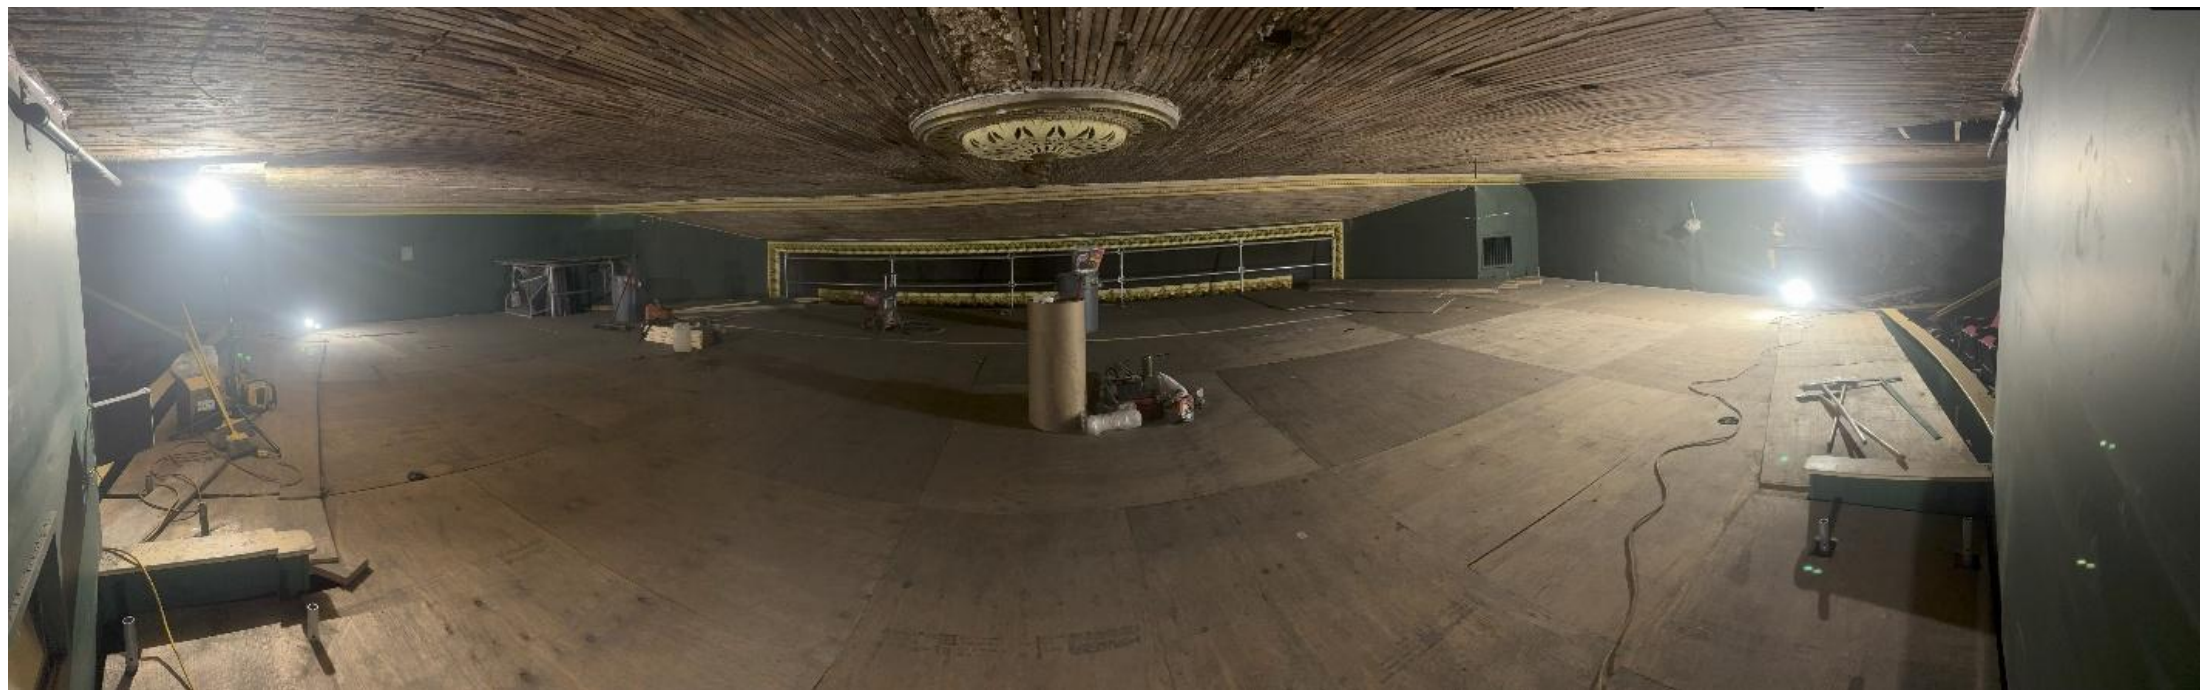
All plaster is removed. Area is clean and ready for drywall installation.

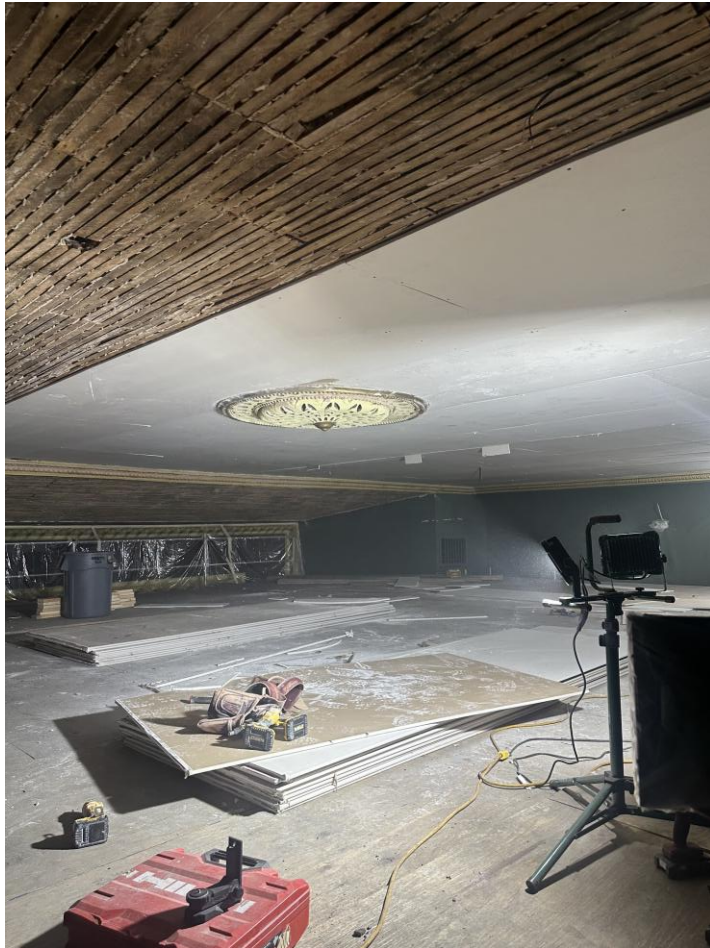
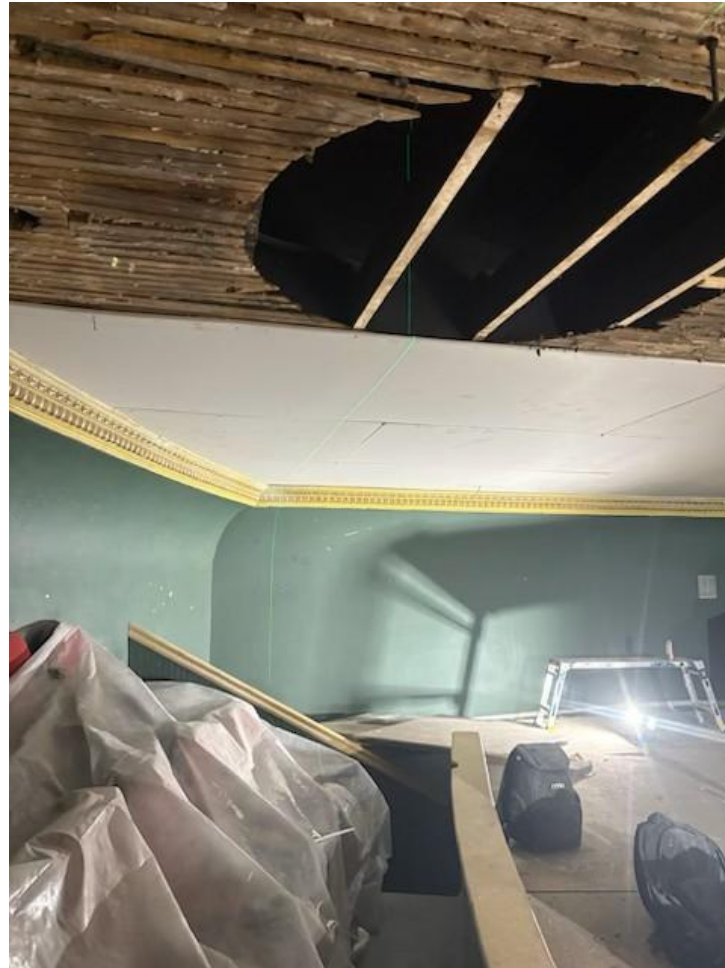
Drywall is going up.

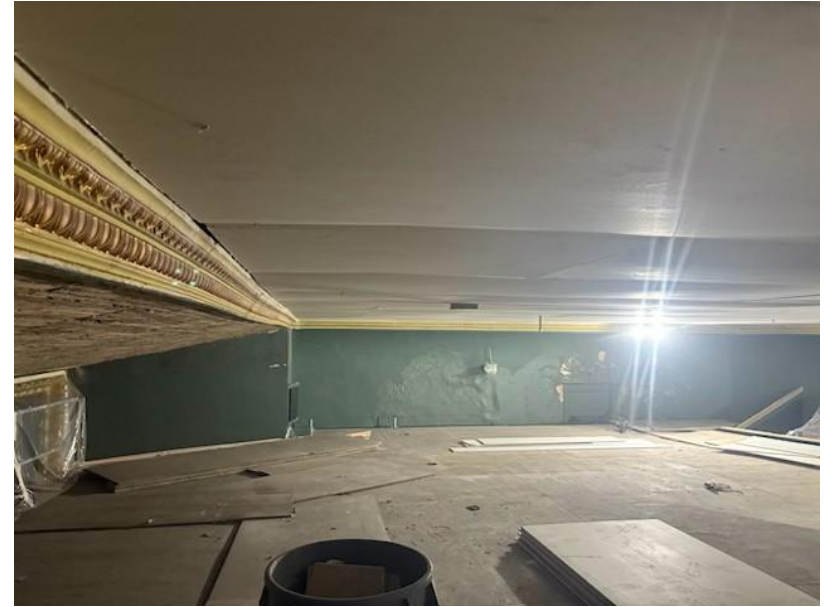
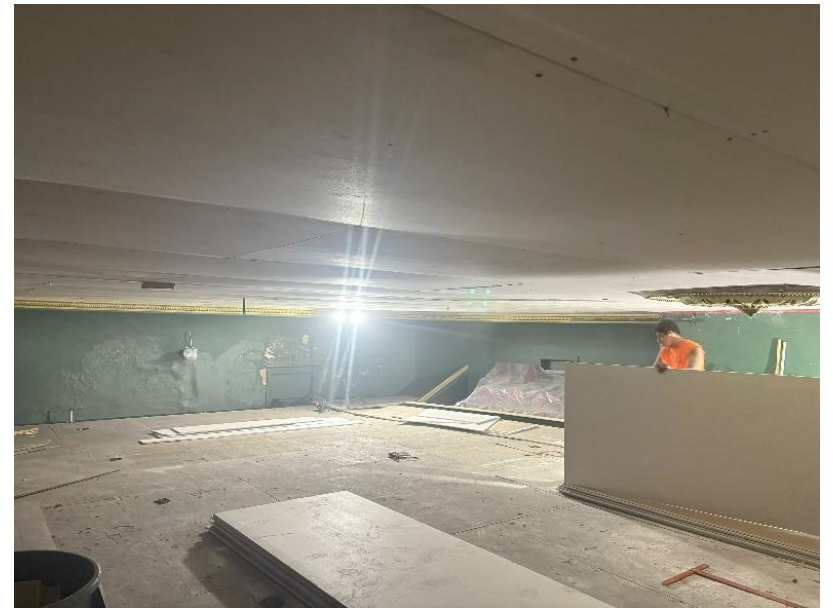
Old ventilation system opening.

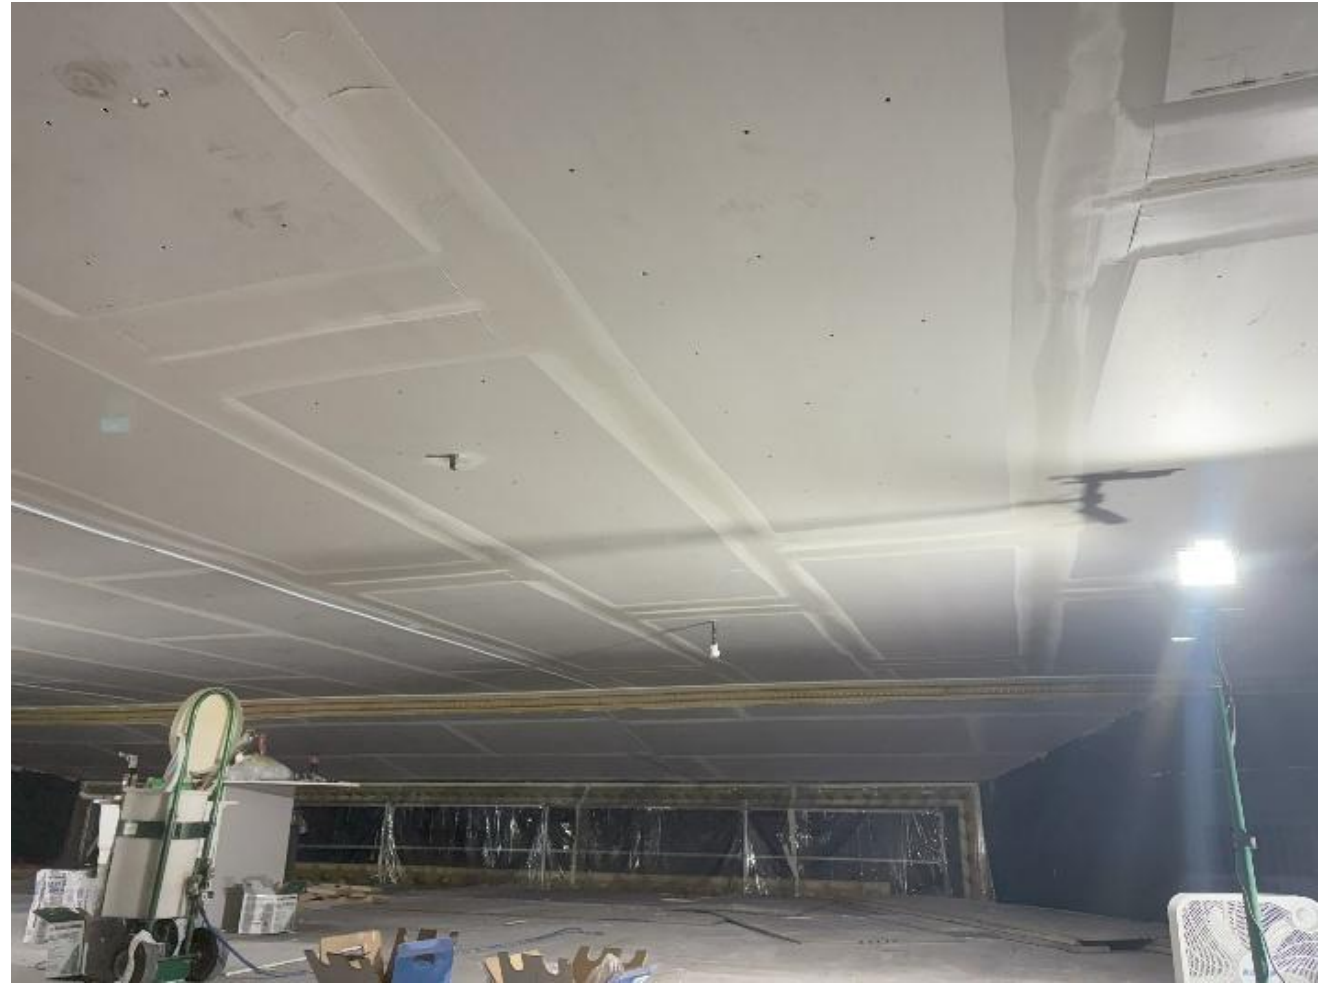
Step 1, prep and pre-fill, and Step 2, application of the first coat (tape coat), have been completed as part of the Windsor Theatre auditorium ceiling drywall installation.

Vinyl expansion joints. are installed in sheetrock ceilings to relieve structural stress and prevent ugly cracks caused by thermal expansion, humidity changes, and building movement.

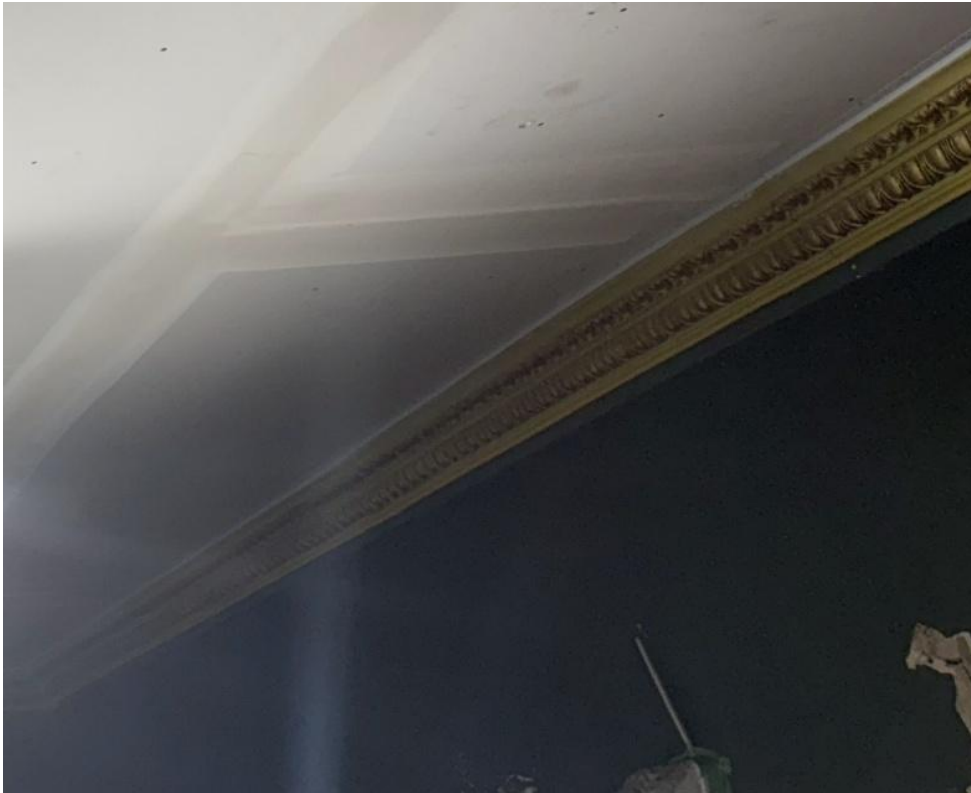
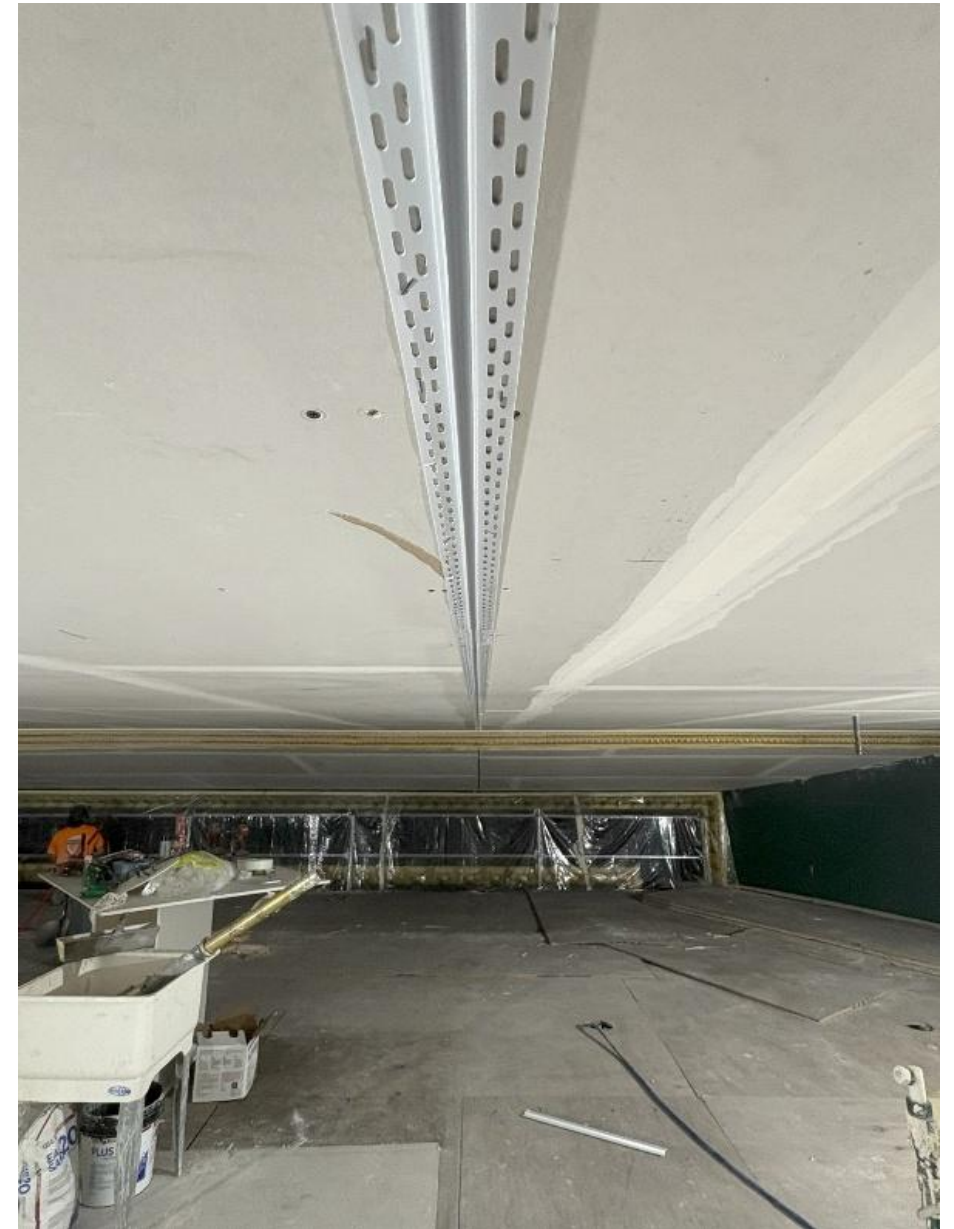
Close-up of the area where the new drywall meets the existing crown molding

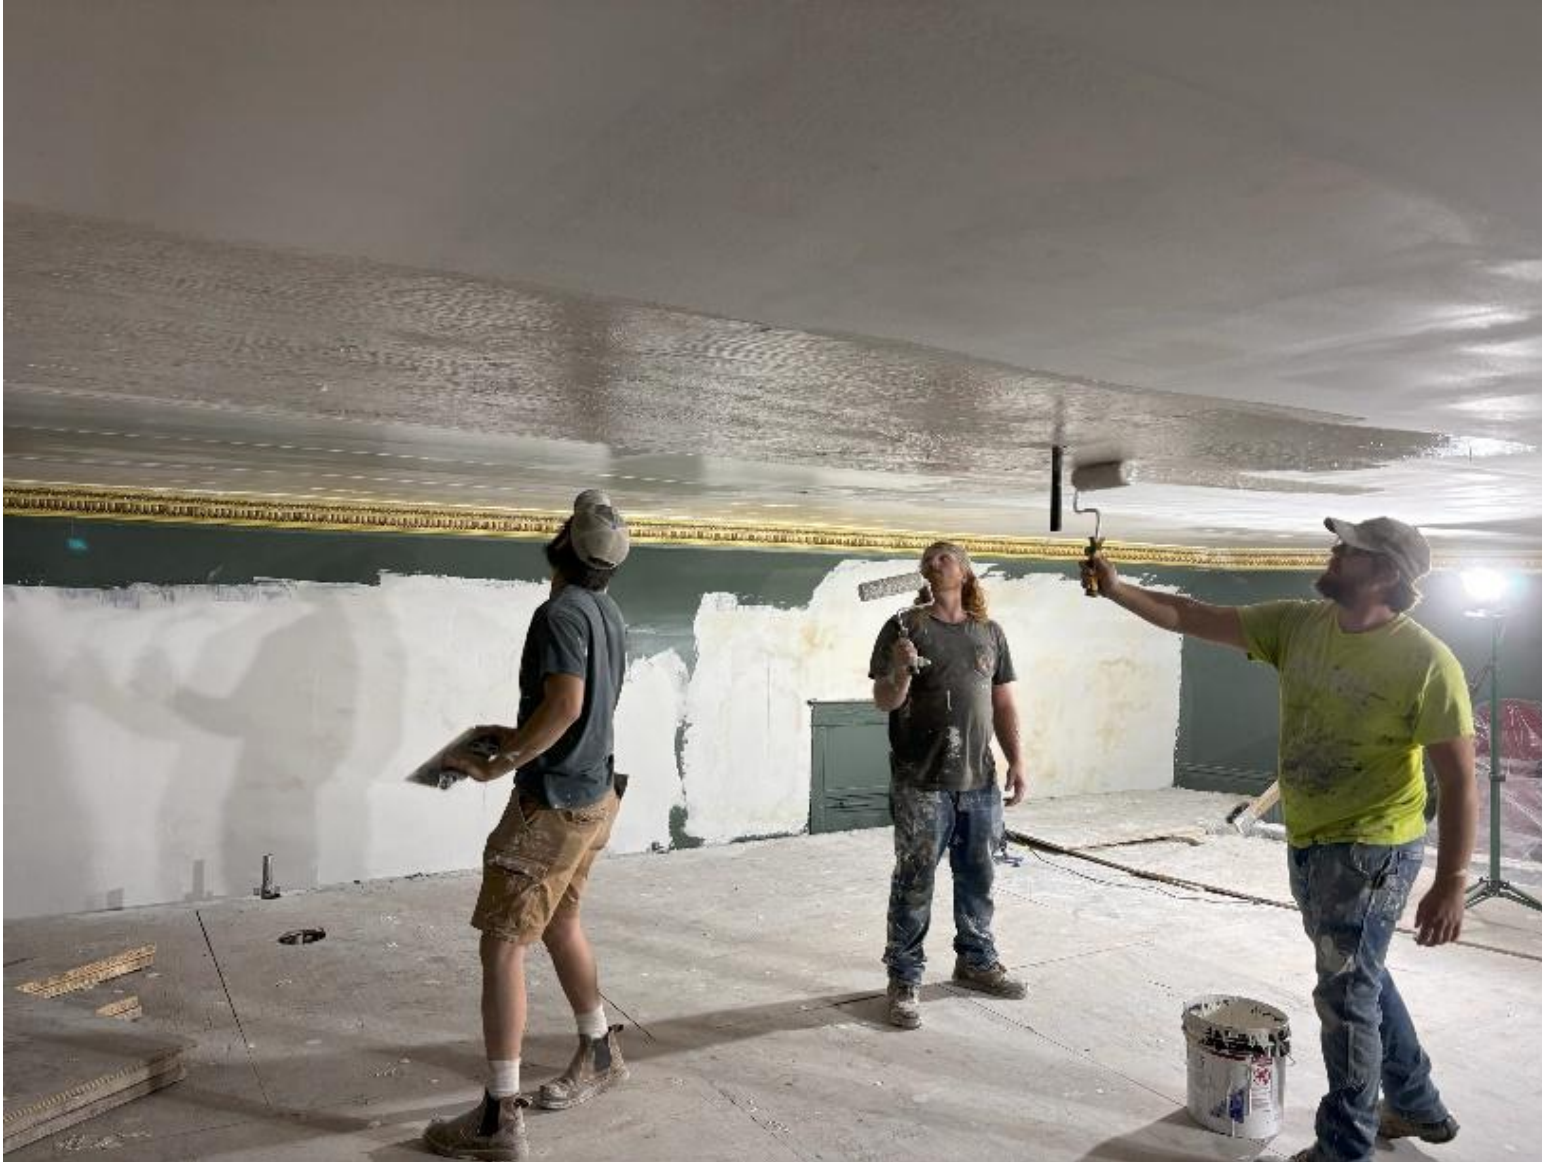
Pro Wall Construction crew members Isaac Shelton, Loudon Franke, and Damien Doran apply the final “milk coat” to the Windsor Theatre auditorium ceiling in preparation for painting scheduled to begin Wednesday, October 21. Note the plaster repairs to the east auditorium wall beneath the crown molding.
