# Windsor Theatre Auditorium Ceiling Project

Updated 10/19/26

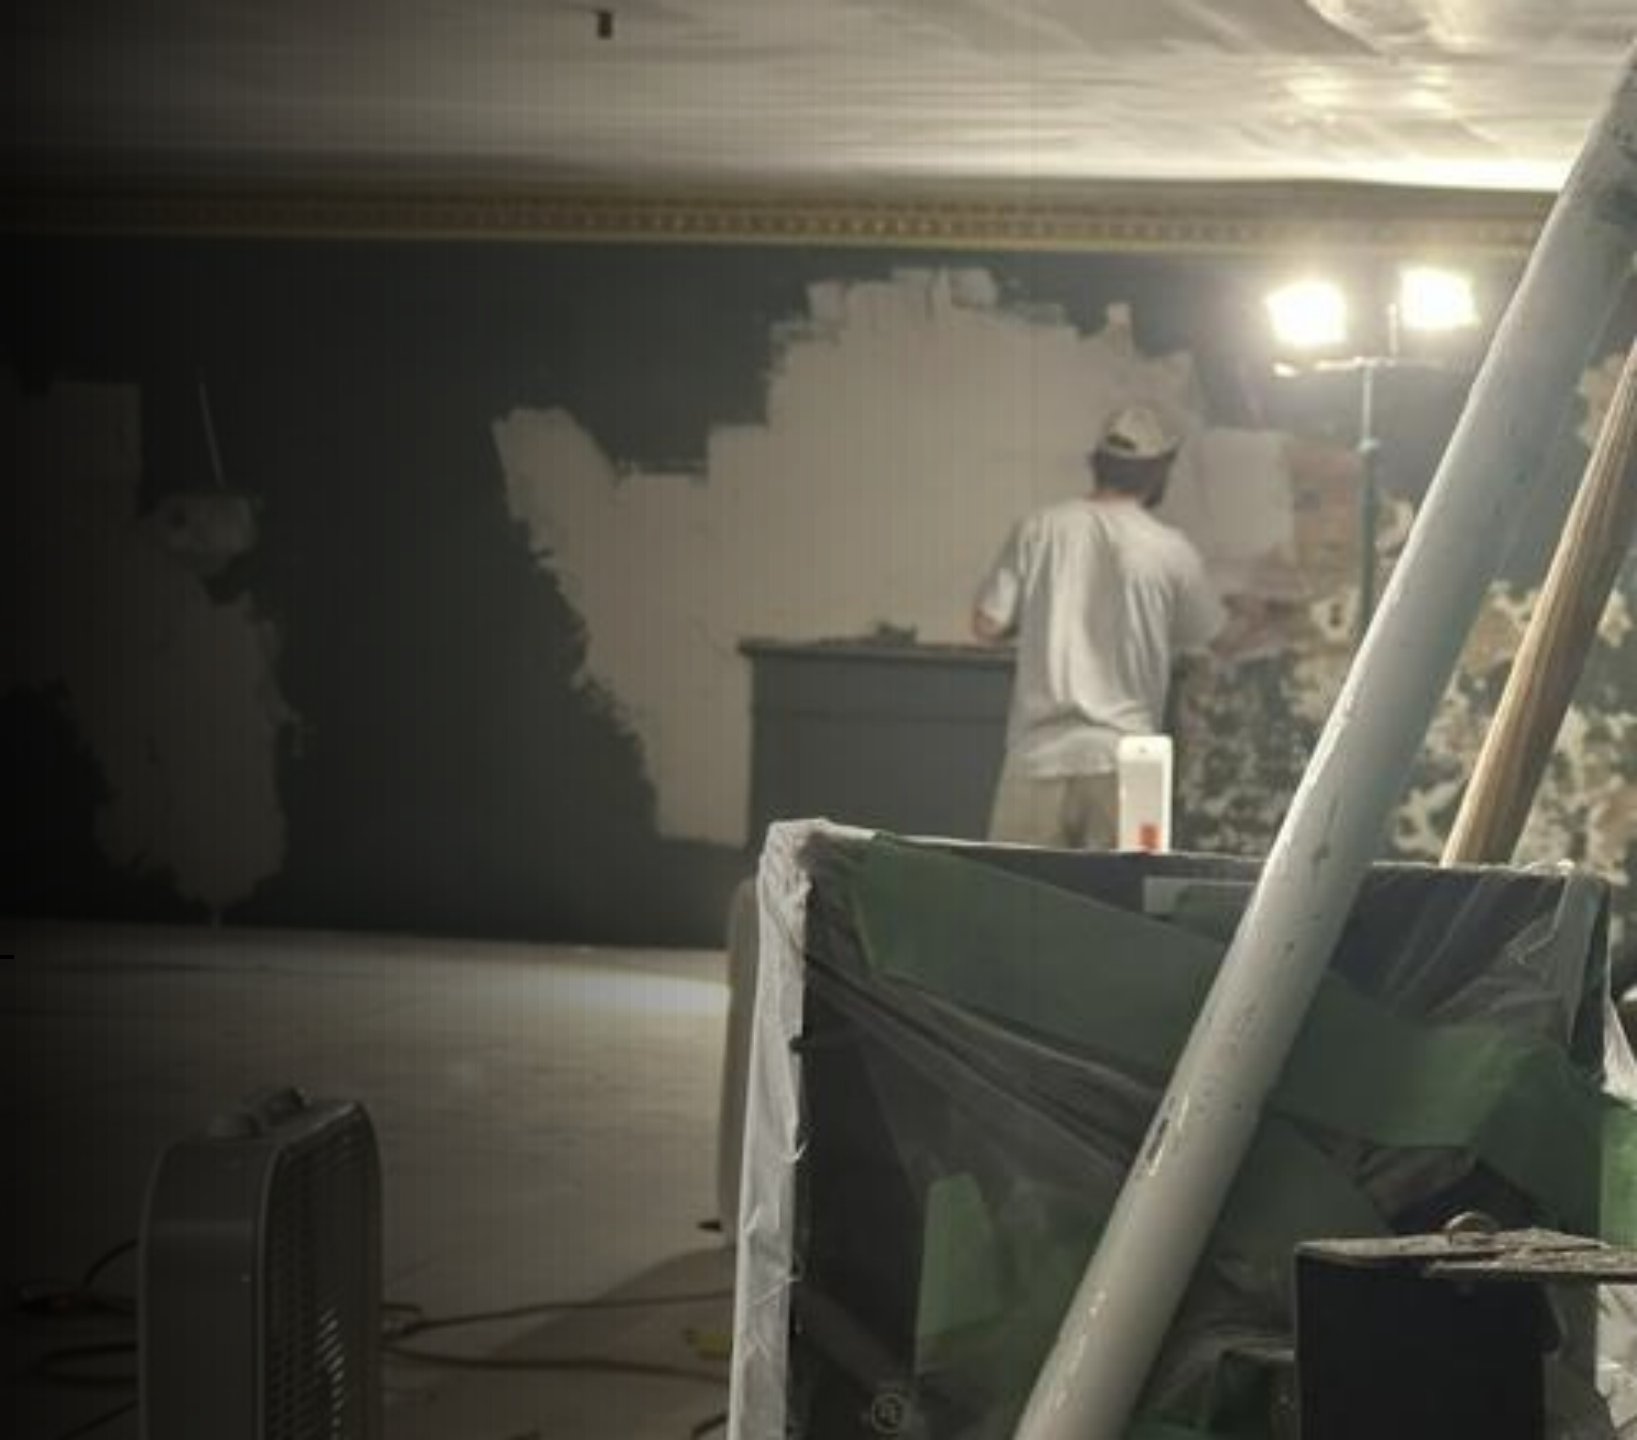
Isaac Shelton works on  
repairs to the east  
interior wall of the  
Windsor Theatre  
auditorium as part of the  
ongoing renovation  
project

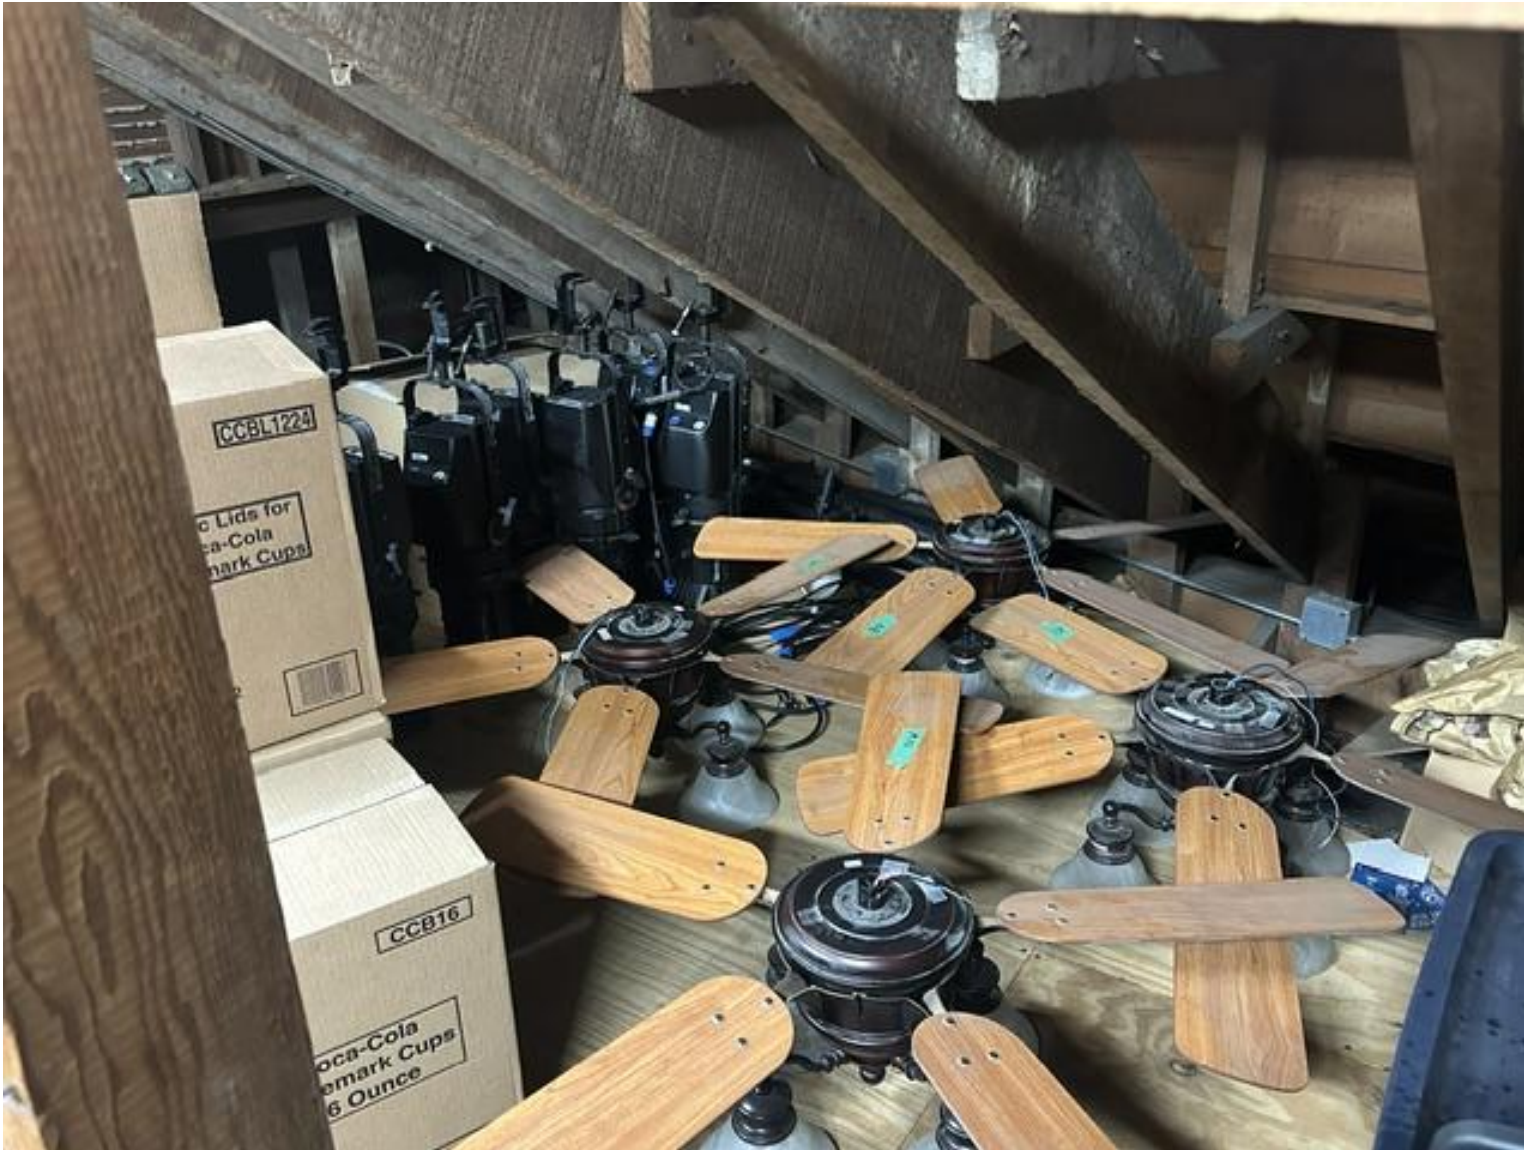
Spotlights and ceiling fans with lights were removed and stored under the balcony while the auditorium ceiling is replaced and painted. Special thanks to Michael Lage of LMD Services of Sheffield for removing the spotlights and A & M Electric of Hampton for removing the ceiling fans with lights

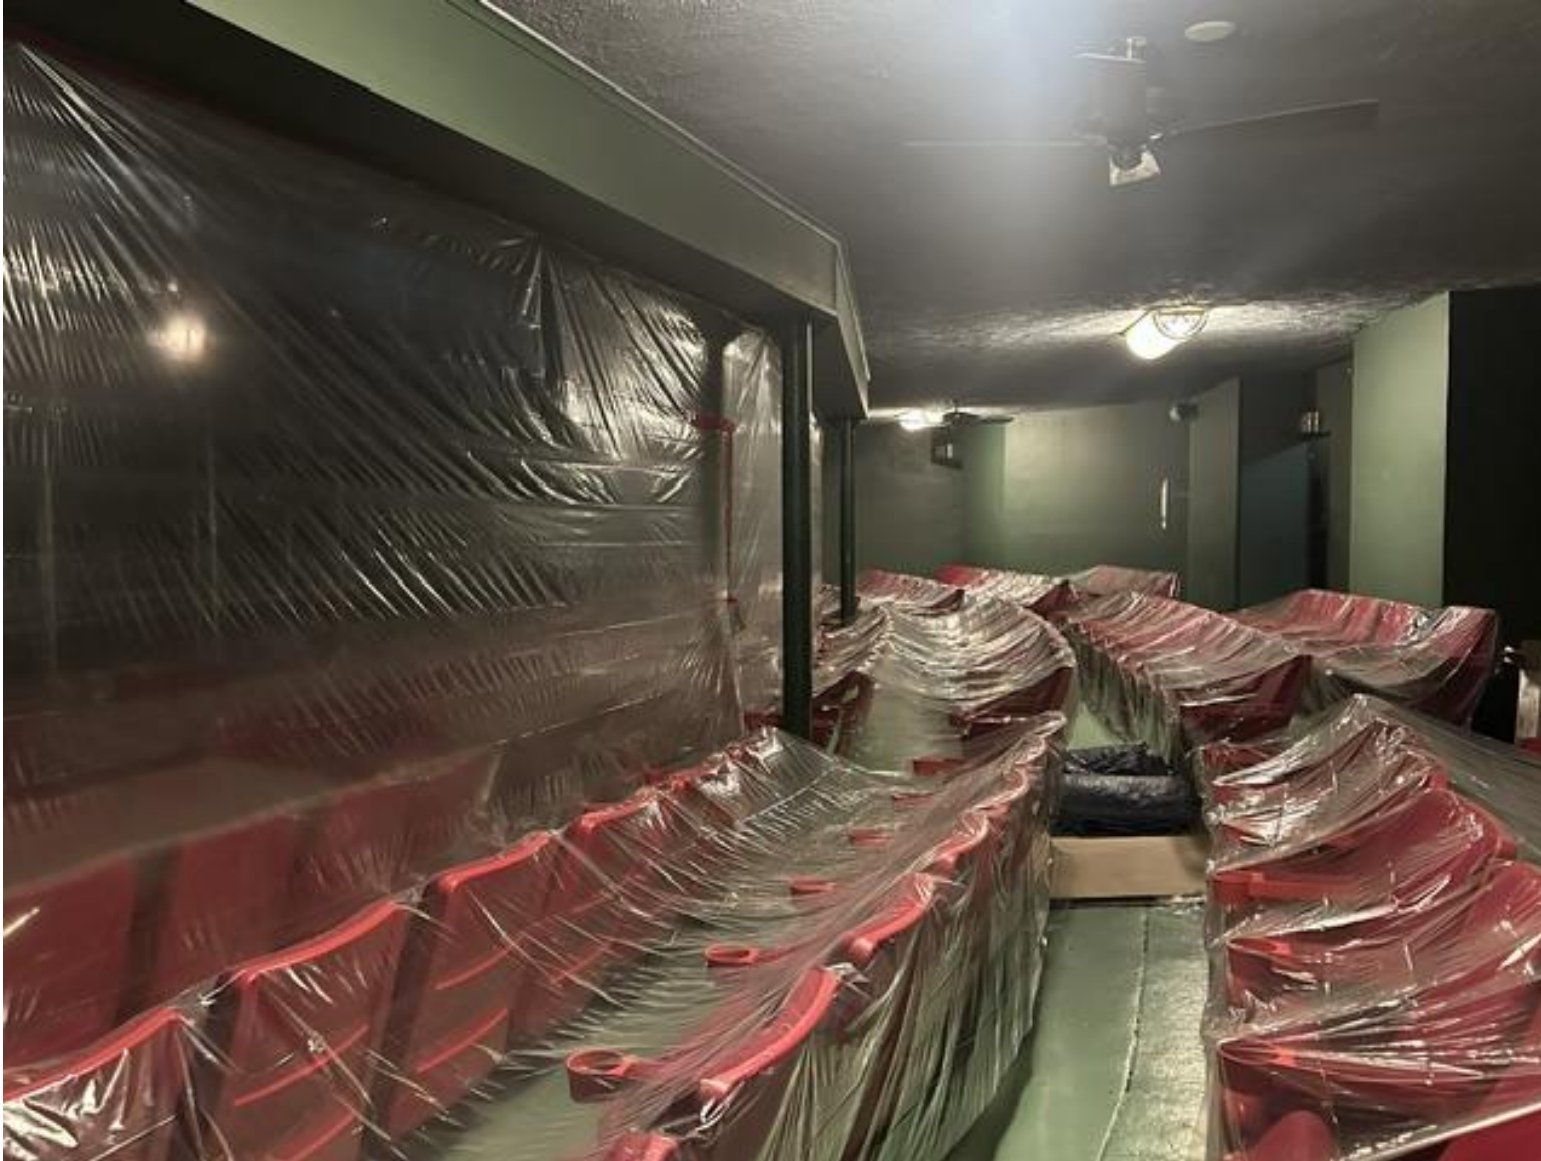
Plastic sheeting has been installed beneath the balcony to help keep dust from spreading into the lobby during removal of the auditorium's existing plaster ceiling.

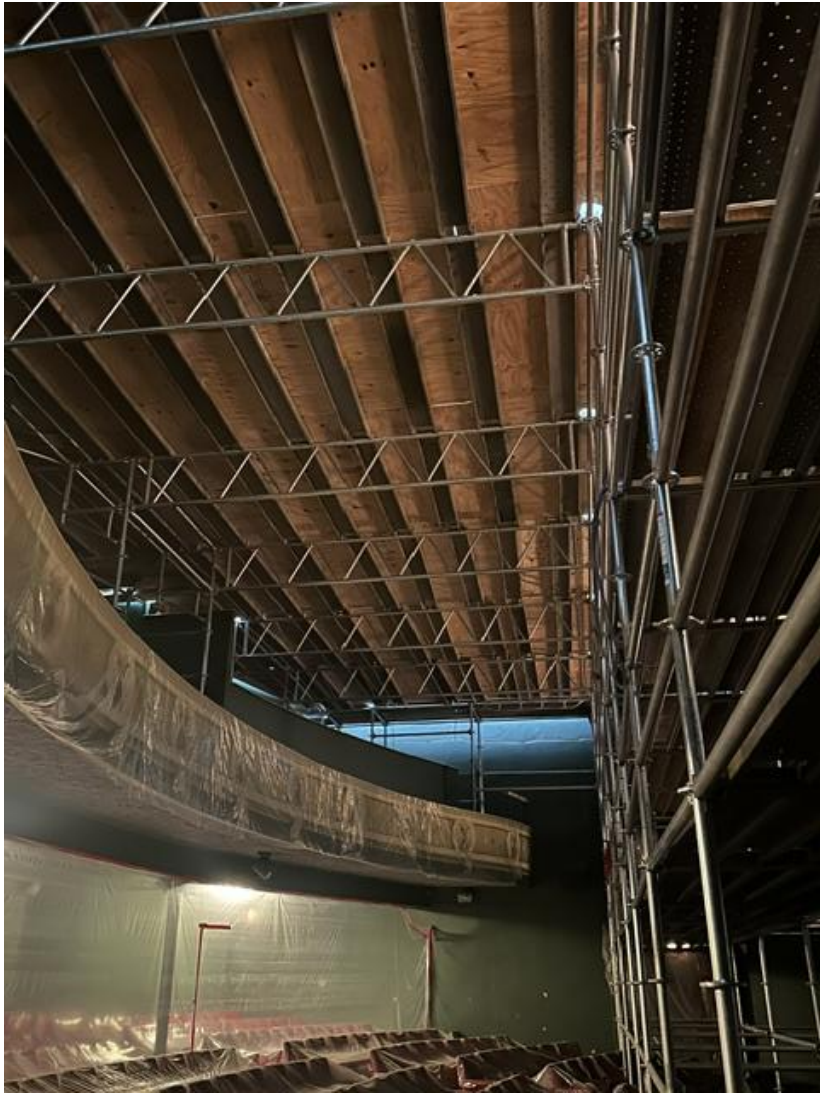
A view of the movie screen through the scaffolding installed throughout the Windsor Theatre auditorium in preparation for ceiling repairs

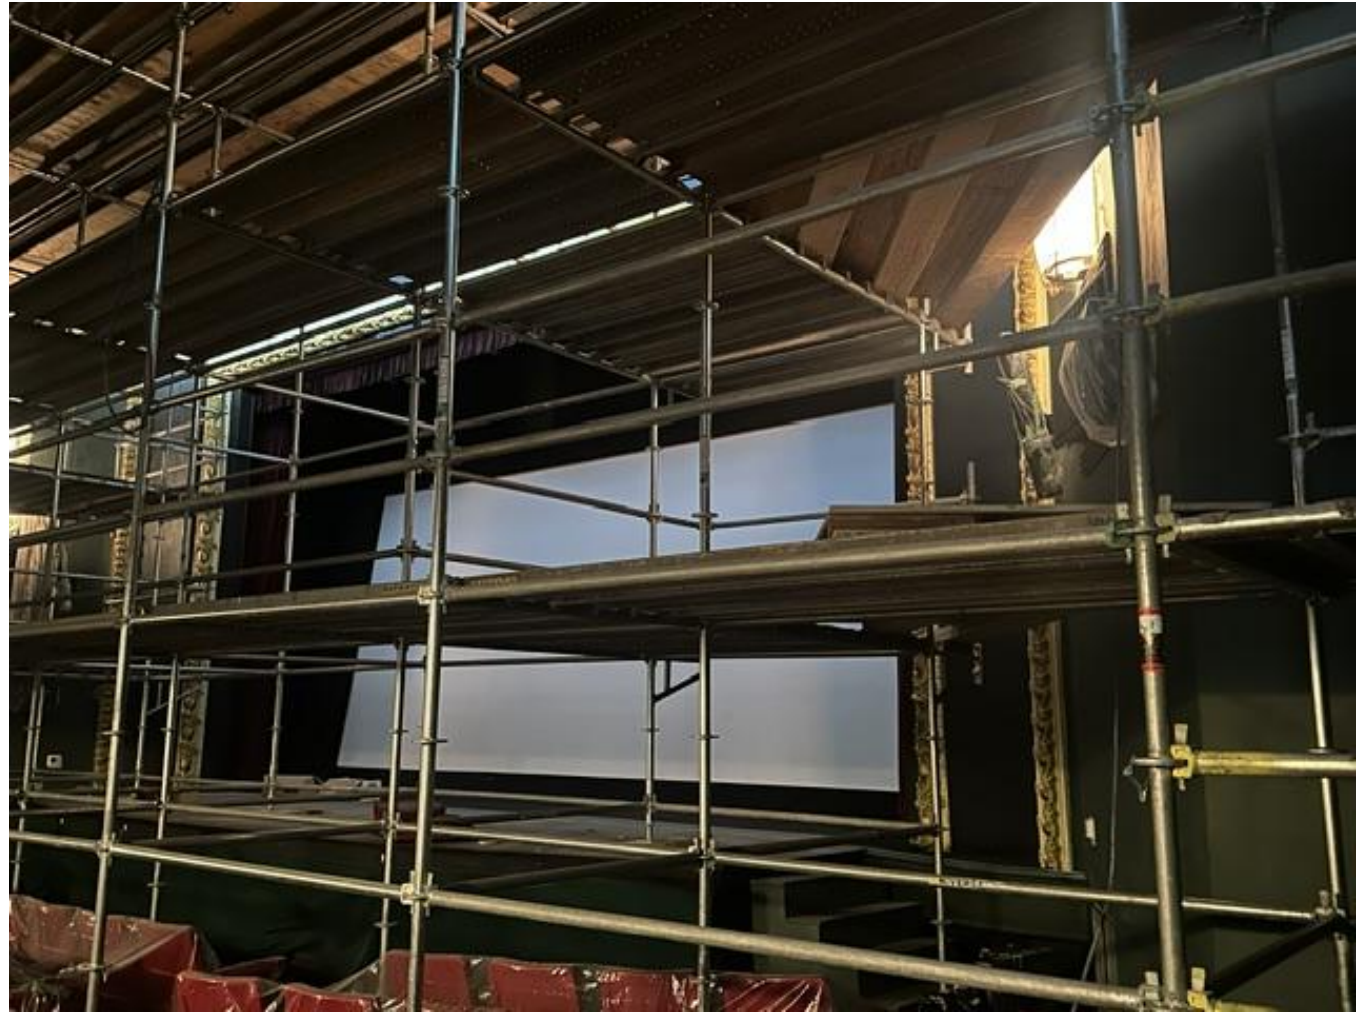
Plywood flooring has been installed on top of the scaffolding, providing a platform for workers to stand on while reaching the Windsor Theatre auditorium ceiling.
